Block motion from detonations of buried near-surface explosive arrays

CRREL Report 80-26

Scott Blouin

December 1980

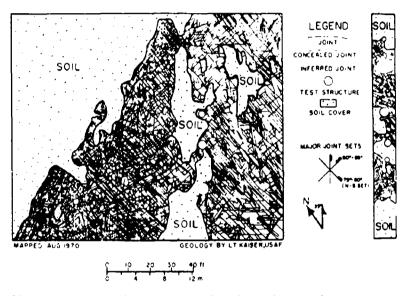
Figure 4. Joint map of STARMET test bed (from Blouin and Kaiser 1972).

A detailed joint map of exposed segments of the testbed surface was prepared by John Kaiser (Blouin and Kaiser 1972) and is reproduced in Figure 4. The map shows only the major joints: actual jointing was even more dense than indicated here. The map shows the west side of the testbed from the explosive array for a distance of 120 ft, the range of the farthest instrumentation holes, as well as a 10-ft band on the east side of the explosive array surrounding the test structures. Only outcrop was mapped, soil-covered

areas are so indicated. Three major joint sets are delineated on the map, a north-south set dipping steeply to the east, a nearly orthogonal set dipping steeply to the north, and a set striking toward the northeast parallel to the explosive array and dipping steeply toward the southeast. It will be shown in the later discussion that the orientation of these joint sets largely controlled the nature and direction of the permanent displacements which occurred in the testbed beyond the DIHEST crater.

It is disturbing to note that the boundary joint, which controlled all permanent displacements on the west side of the testbed and which was so evident post-test both within the structures and for a length of at least 120 ft along the testbed surface, does not appear on the pretest joint map in Figure 4. Unfortunately, a thin veneer of soil covered much of the boundary joint, but approximately 40 ft of its length was exposed pretest. The only manifestation of its intersection with the testbed surface (shown in Fig. 13) is a short section of closely spaced parallel joints approximately 4 ft northwest of the 6-ft structure striking parallel to the common centerline of the structures.

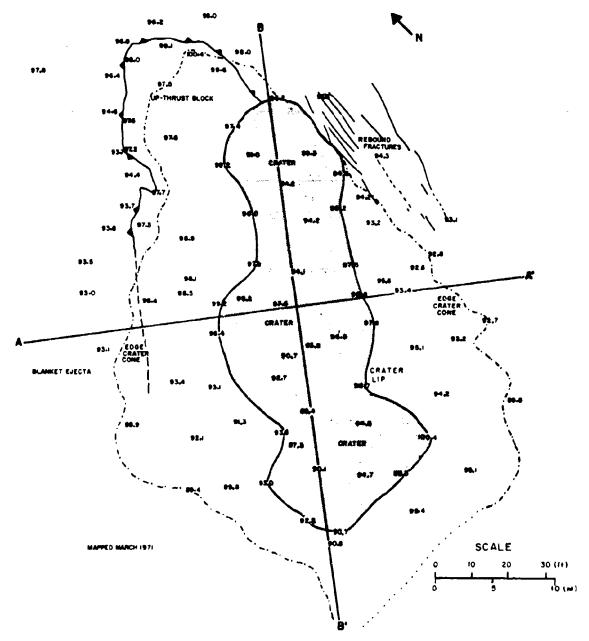
Figure 8. Plan view of STARMET crater (from Blouin and Kaiser 1972).

south set shown in Figure 7 and Figure 8 evidently resulted from the rebound Obviously, the combination of joint orientations and properties and the ground motion field was somehow not right for the type of block relief which occurred on the opposite side of the array. It appears that the major east-west joint set could have provided such relief, since it dipped toward the explosive array on the east side. However, no major block slips occurred and the rock mass rebounded toward the array following its initial compressive loading. Because the crater had already formed by the time of the rebound, the motion could not be resisted by compression of rock within the crater. Thus, the rock mass tended to go into tension which caused en-echelon opening of joints in the north-south set oriented approximately perpendicular to the maximum tensile potential.

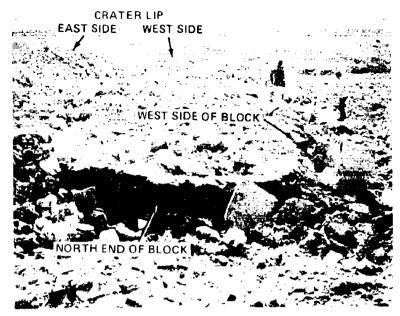
Figure 9. View of the thrust block, looking south (from Blouin and Kaiser 1972).

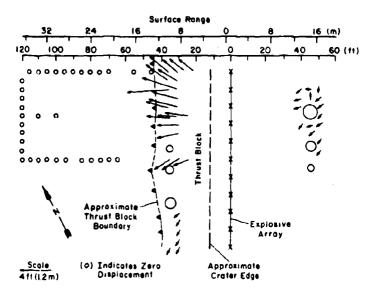
Figure 11. STARMET permanent horizontal displacements (from Blouin and Kaiser 1972).

These numerous open joints within the thrust block signify a general expansion of the block as it moved upward and outward along the boundary joint. Such an expansion is in keeping with the divergent motion imparted by the geometry of the explosive array and the measured permanent displacements shown in Figure 11.

Only 15 survey points on the east side of the explosive array were relocated post-test. These were all in the northeast quadrant at ranges between 40 and 50 ft in the vicinity of structures S₁ and S₂. As shown by the displacement vectors in Figures 11 and 12, motion was upward and horizontally toward the explosive array. Horizontal permanent displacements averaged about 0.5 ft toward the array, generally in a direction perpendicular to the strike of the major north-south joint set. Vertical displacements ranged from about 0.7 ft north of structure S₁ to about 1 ft near structure S₂. No permanent displacements occurred at this range on the west side of the array, being beyond the intersection of the boundary joint.

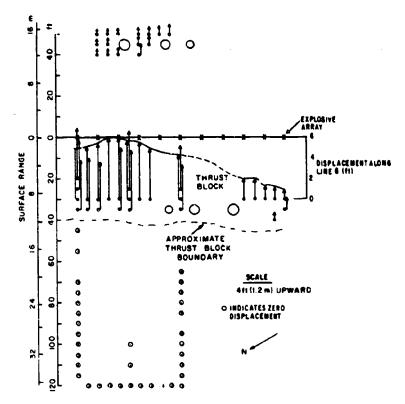
Figure 12. STARMET permanent vertical displacements (from Blouin and Kaiser 1972).

The upward vertical displacements on the east side, shown on the vector plot of Figure 12, evidently resulted from a general bulking of the testbed on that side. Since there were no well defined boundaries to this bulking on the test bed surface, it must gradually lessen with increasing range from the array. Close inspection of the walls of structures S₁ and S₂ in Figures 20 and 23 reveals that in addition to the open rebound joints, other joints, including horizontal ones, have been shaken loose in much the same manner as those within the joint block on the op-

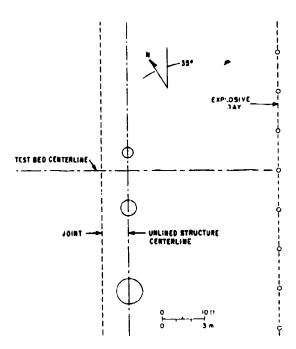
Figure 13. Plan view of assumed joint intersection with the test bed surface (from Blouin and Kaiser 1972).

A schematic plan view of the original joint intersection with the testbed is shown in Figure 13. The joint intersects the surface approximately 7 ft west of the 3-, 4- and 6-ft structures' centerlines and strikes parallel to the explosive array. Figure 14 was constructed by combining measurements made on the testbed surface with the projected intersection at the surface of the joint intersections with the 3-, 4- and 6-ft structures. The displacements along the joint, measured in each of the three structures, are shown in schematic cross section. Total slip of 5.4 ft was measured in the 3-ft structure, dropping to 2.3 ft in the 6-ft structure. Displacements measured along the boundary joint in the structures agreed closely with corresponding measurements made on the thrust block surface.

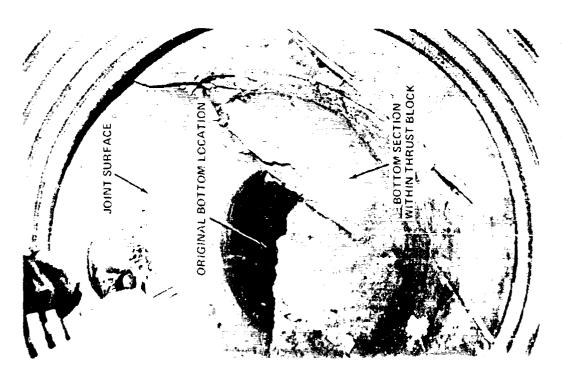
Figure 15. View of the bottom of the 4-ft structure (W_{b}) (from Blouin and Kaiser 1972).

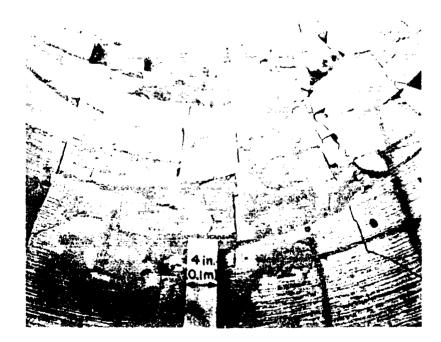
Figure 18. View of south side of the upper 5 ft of the 6-ft structure (from Blouin and Kaiser 1972).

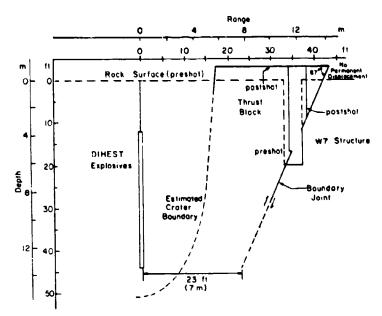
Figure 19. STARMET thrust block, schematic section (from Blouin and Kaiser 1972).

array and thrust block, taken perpendicular to the array and intersecting the 4-ft structure, is shown in Figure 19. If it is assumed that the boundary joint is planar, as suggested by its intersection with the structures, an extension at a constant dip of 67° misses the bottom of the array by 23 ft. Since the true crater extends only 18 ft beyond the array at the testbed surface, it is likely that the joint misses the crater by a substantial margin as well.

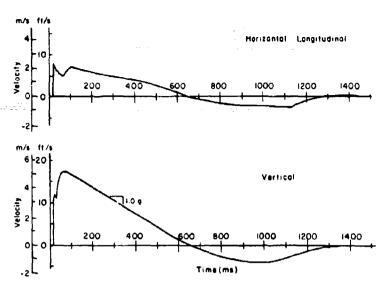
Figure 24. Horizontal longitudinal and vertical velocities at instrumentation hole 15, range—30 ft, depth—4 ft (from Blouin and Kaiser 1972).

shown in Figure 24. These were taken at a depth of 4 ft in instrumentation hole 15, located in the northern end of the block where displacement was at a maximum. Both the horizontal time history (positive velocities indicate motion away from the explosive array) and the vertical time history (positive velocities indicate motion upward) show a rapid rise to an initial peak followed by a short decay and then another

slower rise to a second peak at 80 to 100 milliseconds (ms). The second peak is followed by a long decay to zero at 650 ms into a rebound ending back to zero at 1300 ms. The phase durations of both the positive and negative portions are approximately 650 ms. As shown in Figure 24, the long decay on the vertical time history is essentially linear at a slope of about 1 g. This would indicate that the block was in a state of

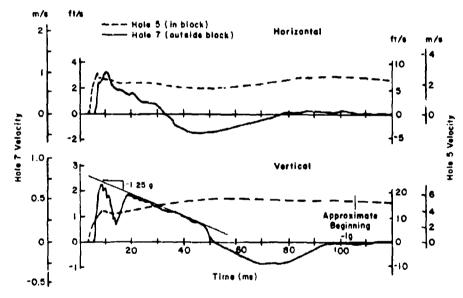
Figure 25. Velocity time histories, instrumentation holes 5 and 7, range – 20 and 40 ft, respectively, depth – 4 ft (from Blouin and Kaiser 1972).

Motion within the block is contrasted with that outside the block in Figure 25, which compares the waveforms from hole 5 with those from hole 7, beyond the boundary joint, at the 4-ft depth. The rise times to initial peak are nearly equal at each location. However, beyond the boundary joint both the vertical and horizontal velocities rapidly decay, while those within the block show only a slight decay and then increase. These essential differences in the waveforms appear within 10 to 12 ms of the onset of motion and indicate that relative displacement along the boundary joint has commenced at this time. The rapid decay beyond the joint continues through both the positive and negative phases, resulting in waveforms more than an order of magnitude shorter than those from within the block. The linear portion of the vertical velocity decay in hole 7 has a slope of 1 1/4 g, an indication of restorative forces slightly in excess of those due to gravity.

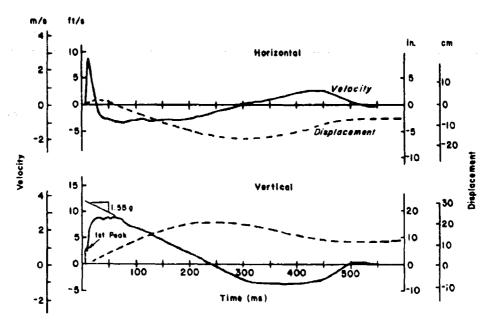
Figure 26. Velocity and displacement, hole 22, range – 60 ft, depth – 15 ft (from Blouin and Kaiser 1972).

Typical vertical and horizontal velocity time histories from a range of 60 ft on the east side of the array (hole 22) are shown in Figure 26. The rise times to first peaks are equivalent to those both within and outside the thrust block on the opposite side. The positive phase duration of the horizontal velocity is slightly shorter than that shown in Figure 25 beyond the thrust block, but the negative phase is about 6½ times as long as

that beyond the block. The positive phase durations on the vertical time history are approximately equal, each lasting ¼ of a second, about the same duration as the negative phase duration on the horizontal time history. The linear portion of the vertical trace has a slope of 1½ g's, indicating some restorative force acting on the testbed in addition to gravity. The time during which this force acts is within the negative phase of the horizontal motion. If it is assumed that this restorative force is responsible for the long negative phase in the horizontal trace, then the net resultant would be a vector pushing the rock down and toward the crater.

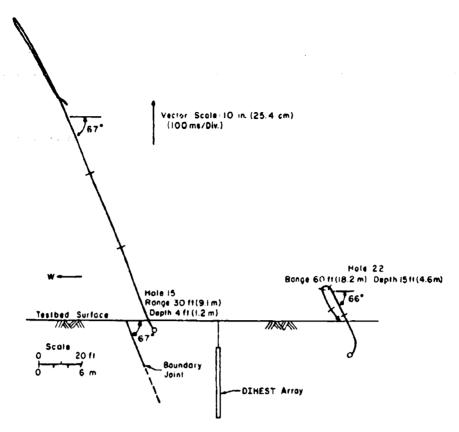
Figure 27. Displacement hodographs for opposite sides of STARMET array.

The mechanics of this restorative force can be hypothesized from Figure 27, which shows displacement hodographs for gage stations located on opposite sides of the explosive array. These were constructed by combining the horizontal. longitudinal and vertical displacement time-histories from the 4-ft depth in hole 5 and from the 15-ft depth in hole 22. They show the displacement trajectories followed by these two points in a plane perpendicular to the explosive array viewed from the south. The point in hole 5, within the thrust block, clearly parallels the boundary joint. The thrust block slid up the joint a maximum of 78 in. at this point, then slid back down a distance of 23 in. Elapsed time was approximately 1300 ms. Indicated permanent displacements were 191/2 in horizontal and 51 in ver-

tical, which agree very well with those measured in the post-test survey at the testbed surface in this area.

The displacement hodograph from hole 22 on the opposite side of the array is surprisingly similar to that from hole 5. Initially, motion is upward and outward away from the explosive array, as would be expected from the initial arrival of compression waves from the detonation. However, within the first 40 ms, the displacement trajectory turns dramatically back toward the explosive array and then follows a path parallel to the boundary joint for nearly 200 ms, reaching a peak displacement of 151/2 in vertically upward and 61/2 in toward the array Following the peak, there is a downward and outward return, similar to that in hole 5, again paralleling the boundary joint. The point comes to rest after about 500 ms, with a permanent displacement of 8 in. vertical and 21/2 in. toward the array. This is in general agreement with the posttest surface displacements measured between the 40- and 50-ft ranges.

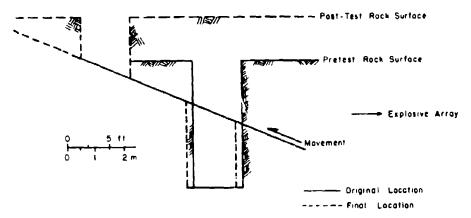
tion is shown in Figure 48 and the bottom section in Figure 49 Plamondon and Browder (1970) hypothesize that the structure was intersected by a joint dipping gently toward the explosive array, as shown schematically in Figure 50. Relative displacement along the joint is similar to that shown in the photograph of structure 2, but the magnitude is much greater. Though structure 4 was only about 20 ft from structures 2 and 3, it suffered relatively little damage from relative displacements along nearly horizontal joint planes. Rather, a block of rock bounded by two vertical joints was propelled nearly 6 in. into the structure on the blastward side as shown in Figure 51. The opposite effect was noticed at the back of the structure, where the same blo:k moved several inches radially outward, indicating that the block, though only a little more than 1 ft thick, was quite extensive in area and extended a considerable distance below the structure.

Figure 50. Hypothesized failure mechanism for DATEX II structure 3 (from Plamondon and Browder 1970).

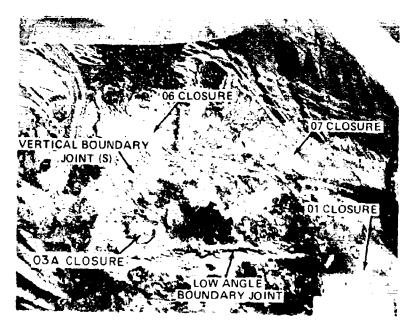
An airphoto of the thrust block is shown in Figure 90, looking east toward the DIHEST array. Closures for structures are 01, 03A, 06, and 07 are identified. The low angle boundary joint dipping toward the DIHEST array is clearly visible as well as the system of vertical joints forming the northern boundary of the thrust block. The eastern edge of the block at the crater boundary is identifiable in the cleared east-west swath. The 03A closure had been upturned by the action of the thrust block wedging the base of the closure against the stationary rock beneath the boundary joint. Figure 91 is a view of the lowangle boundary joint looking north along the joint. The stationary side of the joint is to the left of the photograph while the thrust block lies to the right. The upturned 03A closure can be seen in the background. A projection of the joint in the vicinity of structure 03A back to the DIHEST array is shown in Figure 92. The joint intersects instrumentation hole F04 at a depth of 20 ft, at the location of a cable break which occurred at

Figure 90. Aerial view of the ROCKTEST II thrust block.

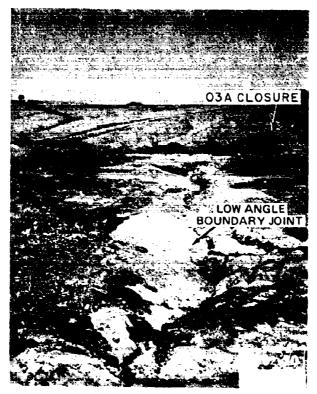
Figure 91. View north along the ROCKTEST II low angle boundary joint.

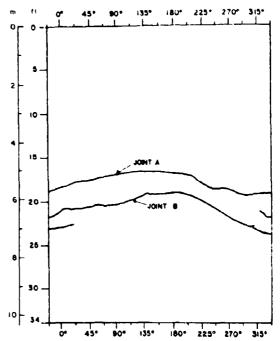
Figure 94. Joints in structure 07 in which major relative motion occurred (from Higgins 1971).

The thrust block observations on the testbed surface are in excellent agreement with post-test observations made in structures 05 and 07 by Higgins (1971) Damage to the lined structure 05 resulted from crushing and buckling near the 90 and 270° azimuths (the 0° azimuth extends toward the DIHEST array), with little or no damage due to relative displacements along preexisting joint surfaces. However, the lined backpacked structure 07, which was within the thrust block as shown in Figure 89, was heavily damaged by relative displacements along the 20° boundary joint. The intersection of this joint with the structure 07 (superimposed on Fig 92) is projected to occur between the 20- and 25-ft depths. Higgins (1971) notes that the major structural damage occurred between the 15- and 23-ft depths. The top of structure 07 moved 61/2 in. horizontally outward from the DIHEST array relative to the bottom as well as 2 in, vertically upward. Motion occurred along two nearly parallel joints which intersected the structure between 15 and 23 ft as shown in Figure 94. The upper joint (Joint A) had a strike of \$ 75° E and dipped toward the array at an angle of 19°, while the lower joint had a strike of \$ 44° E and dipped toward the array at an angle of 28°. The orientation and projected intersection of those two joints with the explosive array is shown in Figure 95. As was often the case, neither of these joints was identified before the test. From Higgins's (1971) observations, it would appear that there was some branching of the displacements along at least two low-angle joints near the southern boundary of the thrust block. This is probably also evidenced on the testbed surface by the branching noted in the vicinity of structure 01.
